# ASPEN/PITKIN COUNTY AIRPORT

NON-STANDARD CONDITIONS  
RELOCATE RUNWAY 80' WEST

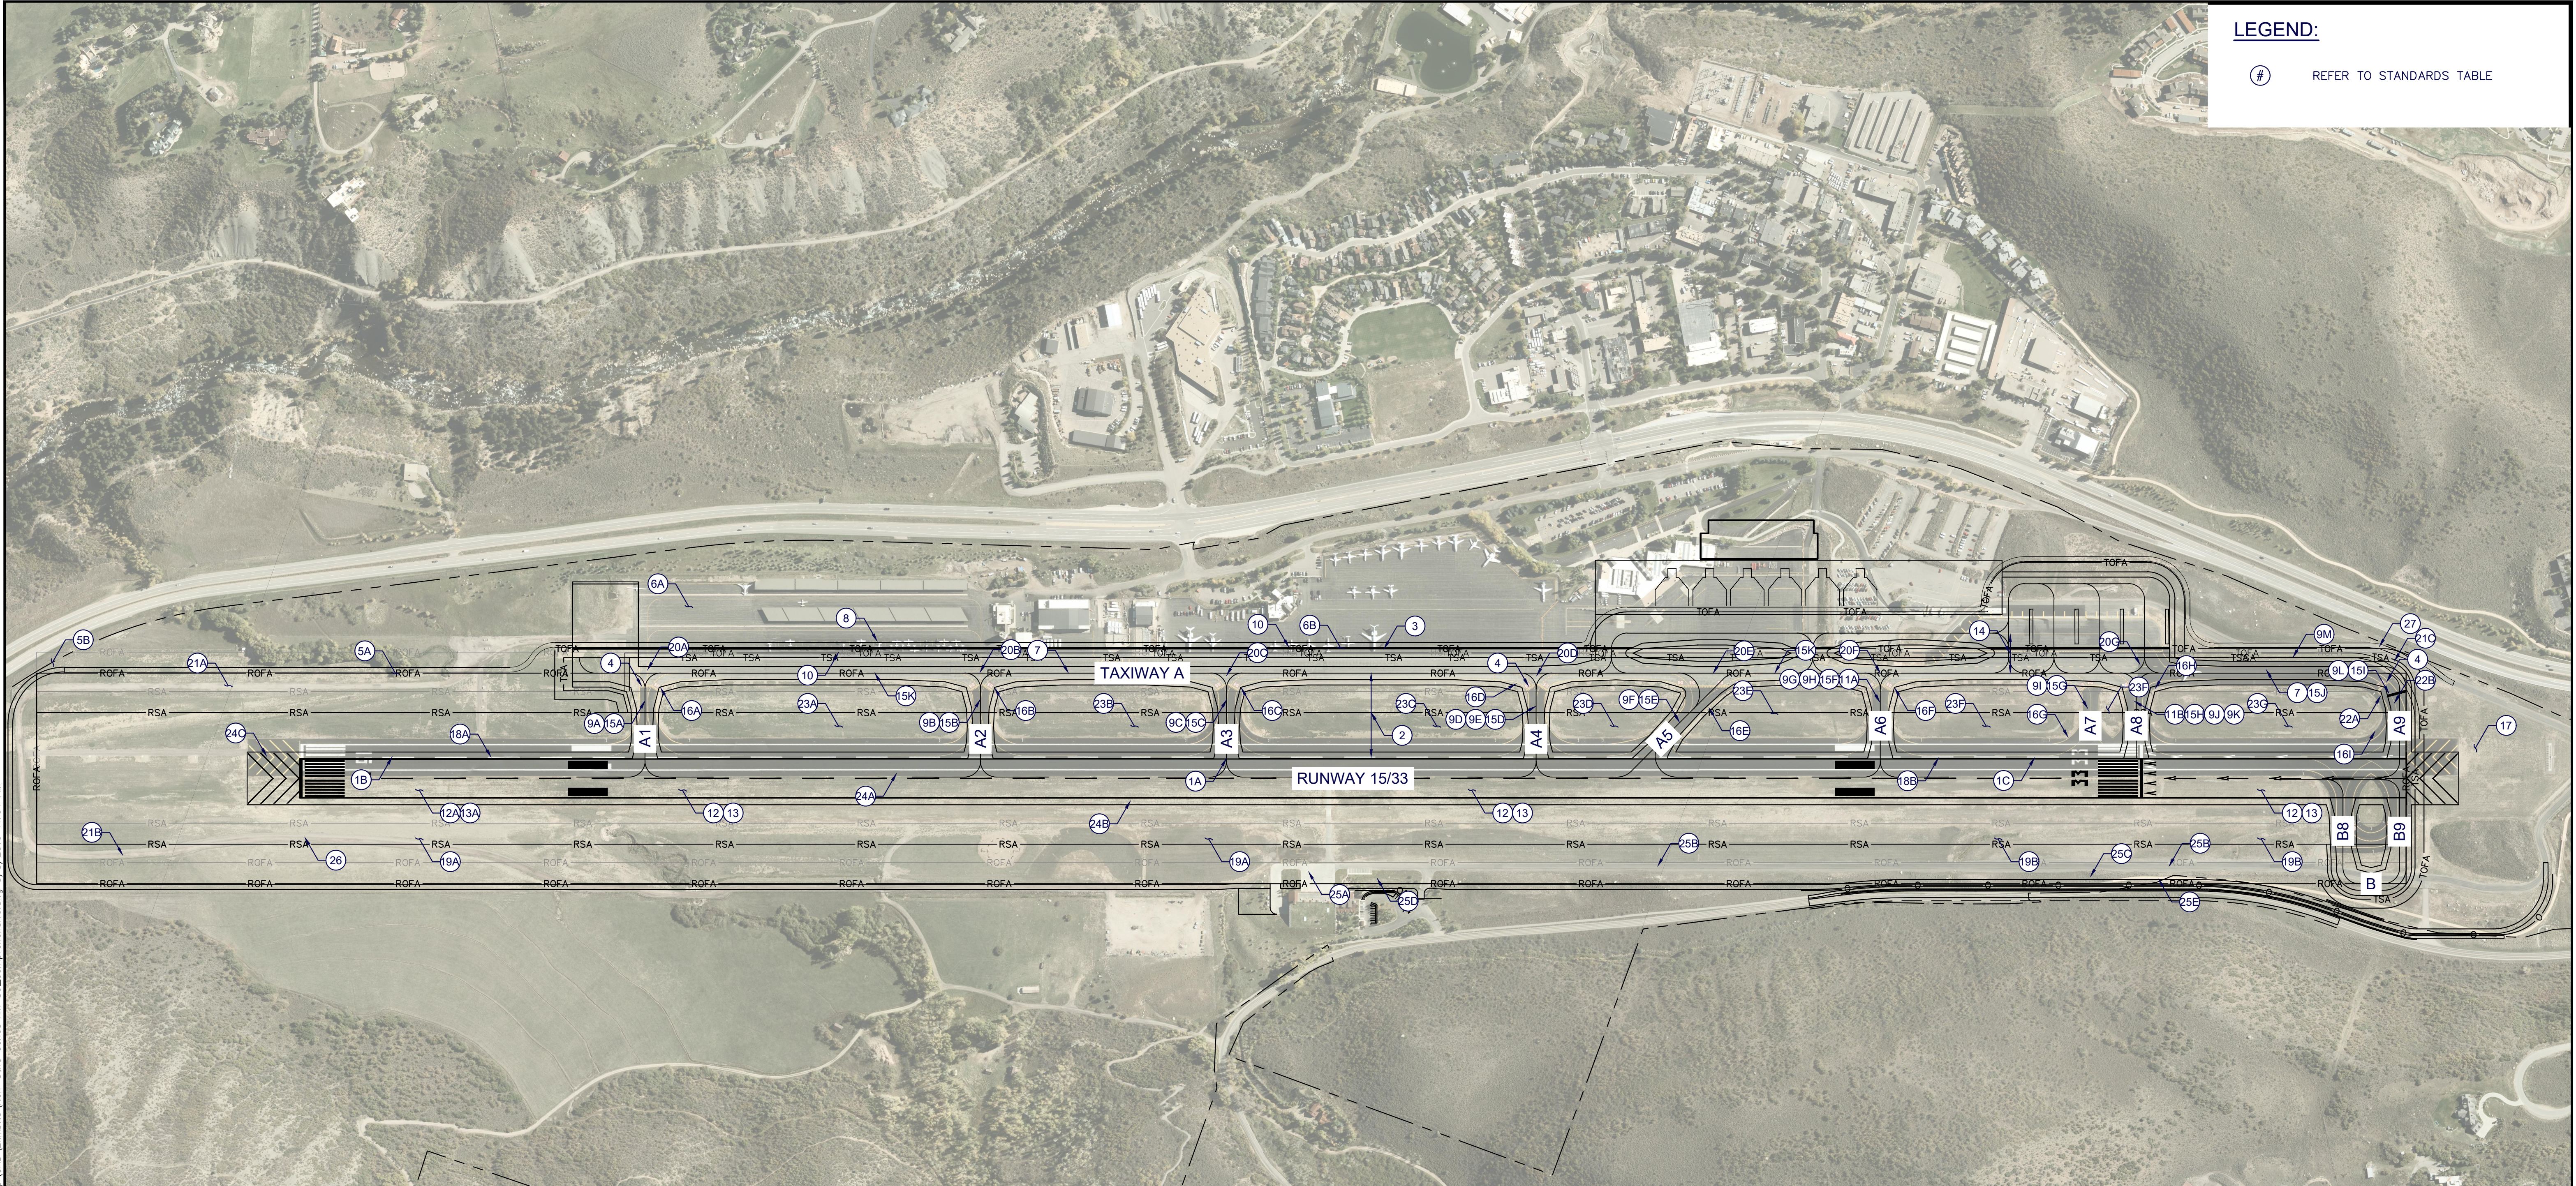
| NON-STANDARD CONDITIONS INCLUDED ON MAY 9, 2016 ALP | | | | | | | | | |
|---|---|---|---|---|---|---|---|---|---|
| 1 | 1A | Runway Longitudinal Slope | 1.5% Maximum | 1.95% End to End Overall 2.3% Maximum | Same as existing | Aug. 6 1991<br>90-ANM/D-173-NRA | 150/5300-13A<br>Chapter 3<br>Section 313.b | Utilize existing MOS<br>Improve condition if feasible | Raise north end or runway to reduce slope in landing zone |
| | 1B | Runway Longitudinal Slope End 1/4 of Runway - 15 End | 0.8% Maximum | Up to 2.2% | Same as existing | Aug. 6 1991<br>90-ANM/D-173-NRA | 150/5300-13A<br>Chapter 3<br>Section 313.b | Utilize existing MOS<br>Improve condition if feasible | Raise north end or runway to reduce slope in landing zone |
| | 1C | Runway Longitudinal Slope End 1/4 of Runway - 33 End | 0.8% Maximum | Up to 2.3% | Same as existing | Aug. 6 1991<br>90-ANM/D-173-NRA | 150/5300-13A<br>Chapter 3<br>Section 313.b | Utilize existing MOS<br>Improve condition if feasible | Lower runway end to reduce slope in landing zone if feasible |
| 2 | | Separation Standards: Runway Centerline to Taxiway Centerline | 400 Feet | 320 Feet | Will be revised with runway shift | 97-DEN-178-NRA | 150/5300-13A<br>Appendix 7<br>Table A7-9 | Correct non-standard condition | |
| 3 | | Taxiway Object Free Area (Parallel Taxiway A) | 186 Feet | 169 Feet<br>(93' West Side, 76' East Side) | Will be revised with runway shift | 97-DEN-178-NRA | 150/5300-13A<br>Chapter 4<br>Table 4-1 | Correct non-standard condition | |
| 4 | | Taxiway Holdlines From Runway Centerline | 328 Feet | 272.5 Feet | Will be revised with runway shift | 97-DEN-178-NRA | 150/5300-13A<br>Appendix 7<br>Table A7-9 | Correct non-standard condition | |
| 5 | 5A | Runway Object Free Area (ROFA) - Trees on Northeast corner | Precludes objects not fixed by function | Trees inside ROFA on Northeast Corner of Airfield | Trees to be removed | Aug. 7, 1995<br>95-DEN-080-NRA | 150/5300-13A<br>Chapter 3<br>Section 309 | Correct non-standard condition | |
| | 5B | Runway Object Free Area (ROFA) - AOA fence on Northeast corner | Precludes objects not fixed by function | Portion of Security Fence Inside ROFA on Northeast Corner of Airfield | Fence fixed by function | Aug. 7, 1995<br>95-DEN-080-NRA | 150/5300-13A<br>Chapter 3<br>Section 309 | Utilize existing MOS | |
| 6 | 6A | Apron Surface Gradient | 1.0% Maximum | Up to 2.6% | Same as existing | Jun. 20, 1996<br>96-DEN-057-NRA | 150/5300-13A<br>Chapter 5<br>Section 508 | Utilize existing MOS<br>Improve condition if feasible | Change gradients to slope away from new terminal and improve gradients where feasible |
| | 6B | Apron Edge Taxiway Surface Gradient | 1.5% Maximum | Up to 2.5% | Same as existing | Jun. 20, 1996<br>96-DEN-057-NRA | 150/5300-13A<br>Chapter 5<br>Section 508 | Utilize existing MOS<br>Improve condition if feasible | |
| 7 | | Parallel Taxiway Longitudinal Gradient | 1.5% Maxaximum | Up to 2.5% | Same as existing | Apr. 22, 2003<br>2003-ANM-24-NRA | 150/5300-13A<br>Chapter 4<br>Section 418.b | Utilize existing MOS<br>Improve condition if feasible | |
| 8 | | Tiedown Layout | 70 Feet Tail to Tail and 49 Feet Between Wing Anchors | 45 Feet Tail to Tail and 24 Feet Between Wing Anchors | Will be revised with runway shift | 97-DEN-178-NRA | 150/5300-13A<br>Appendix 5<br>Figure A5-1 | Utilize existing MOS | Propose to leave condition as is. Spacing works well for FBO's use |
| 9 | 9A | TW A1 Safety Area Gradient | 1.5% to 3.0% | Above 3.0% on North side<br>Below 1.5% on South Side | Same as existing | Apr. 22, 2003<br>2003-ANM-24-NRA | 150/5300-13A<br>Chapter 4<br>Section 418.b(6) | Correct or improve non-standard condition<br>Utilize existing MOS if not fully corrected | |
| | 9B | TW A2 Safety Area Gradient | 1.5% to 3.0% | Below 1.5% on South Side | Same as existing | Apr. 22, 2003<br>2003-ANM-24-NRA | 150/5300-13A<br>Chapter 4<br>Section 418.b(6) | Correct or improve non-standard condition<br>Utilize existing MOS if not fully corrected | |
| | 9C | TW A3 Safety Area Gradient | 1.5% to 3.0% | Above 3.0% on North side<br>Below 1.5% on South Side | Same as existing | Apr. 22, 2003<br>2003-ANM-24-NRA | 150/5300-13A<br>Chapter 4<br>Section 418.b(6) | Correct or improve non-standard condition<br>Utilize existing MOS if not fully corrected | |
| | 9D | TW A4 Safety Area Gradient | 1.5% to 3.0% | Above 3.0% on North side<br>Below 1.5% on South Side | Same as existing | Apr. 22, 2003<br>2003-ANM-24-NRA | 150/5300-13A<br>Chapter 4<br>Section 418.b(6) | Correct or improve non-standard condition<br>Utilize existing MOS if not fully corrected | |
| | 9E | TW A4 Shoulder Transverse Gradient | 1.5% to 5.0% | Below 1.5% on South side | Same as existing | Apr. 22, 2003<br>2003-ANM-24-NRA | 150/5300-13A<br>Chapter 4<br>Section 418.b(6) | Correct or improve non-standard condition<br>Utilize existing MOS if not fully corrected | |
| | 9F | TW A5 Safety Area Gradient | 1.5% to 3.0% | Below 1.5% on South Side | Same as existing | Apr. 22, 2003<br>2003-ANM-24-NRA | 150/5300-13A<br>Chapter 4<br>Section 418.b(6) | Correct or improve non-standard condition<br>Utilize existing MOS if not fully corrected | |
| | 9G | TW A6 Safety Area Gradient | 1.5% to 3.0% | Above 3.0% on North side<br>Below 1.5% on South Side | Same as existing | Apr. 22, 2003<br>2003-ANM-24-NRA | 150/5300-13A<br>Chapter 4<br>Section 418.b(6) | Correct or improve non-standard condition<br>Utilize existing MOS if not fully corrected | |
| | 9H | TW A6 Shoulder Transverse Gradient | 1.5% to 5.0% | Below 1.5% on South side | Same as existing | Apr. 22, 2003<br>2003-ANM-24-NRA | 150/5300-13A<br>Chapter 4<br>Section 418.b(6) | Correct or improve non-standard condition<br>Utilize existing MOS if not fully corrected | |
| | 9I | TW A7 Safety Area Gradient | 1.5% to 3.0% | Above 3.0% on North side<br>Below 1.5% on South Side | Same as existing | Apr. 22, 2003<br>2003-ANM-24-NRA | 150/5300-13A<br>Chapter 4<br>Section 418.b(6) | Remove Taxiway A7 | |
| | 9J | TW A8 Safety Area Gradient | 1.5% to 3.0% | Above 3.0% on North side<br>Below 1.5% on South Side | Same as existing | Apr. 22, 2003<br>2003-ANM-24-NRA | 150/5300-13A<br>Chapter 4<br>Section 418.b(6) | Correct or improve non-standard condition<br>Utilize existing MOS if not fully corrected | |
| | 9K | TW A8 Shoulder Transverse Gradient | 1.5% to 5.0% | Below 1.5% on South side | Same as existing | Apr. 22, 2003<br>2003-ANM-24-NRA | 150/5300-13A<br>Chapter 4<br>Section 418.b(6) | Correct or improve non-standard condition<br>Utilize existing MOS if not fully corrected | |
| | 9L | TW A9 Safety Area Gradient | 1.5% to 3.0% | Above 3.0% on North side | Same as existing | Apr. 22, 2003<br>2003-ANM-24-NRA | 150/5300-13A<br>Chapter 4<br>Section 418.b(6) | Correct or improve non-standard condition<br>Utilize existing MOS if not fully corrected | |
| | 9M | TW A Safety Area Gradient From TW A8 to TW A9 | 1.5% to 3.0% | Above 3.0% on East side | Same as existing | Apr. 22, 2003<br>2003-ANM-24-NRA | 150/5300-13A<br>Chapter 4<br>Section 418.b(6) | Correct or improve non-standard condition<br>Utilize existing MOS if not fully corrected | |
| 10 | | Separation Standard - Runway Centerline to Parked Aircraft | 500 Feet | 400 Feet (ROFA) | 493 Feet (R/W to T/W Separation Plus TOFA) | | 150/5300-13A<br>Appendix 7<br>Table A7-9 | Correct non-standard condition | |
| 11 | 11A | Longitudinal Gradient Taxiway A6 | 1.5% Maximum | Uo to 2% | Same as existing | Jun. 13, 2006<br>2006-ANM-113-NRA | 150/5300-13A<br>Chapter 4<br>Section 418.b | Utilize existing MOS<br>Improve condition if feasible | |
| | 11B | Longitudinal Gradient Taxiway A8 | 1.5% Maximum | Up to 2% | Same as existing | Jun. 13, 2006<br>2006-ANM-113-NRA | 150/5300-13A<br>Chapter 4<br>Section 418.b | Utilize existing MOS<br>Improve condition if feasible | |
| 12 | | West Side Runway Safety Area Transverse Gradient | No grade break in RSA | Grade break in RSA, slopes toward runway, drainage swale in RSA | Same as existing | Jun. 13, 2006<br>2006-ANM-268-NRA | 150/5300-13A<br>Chapter 3<br>Figure 3-23 | Correct non-standard condition | |
| 13 | | Runway Safety Area Transverse Gradient | 1.5% to 3.0% | Below 1.5% | Will be revised with runway shift | Jun. 13, 2006<br>2006-ANM-571-NRA | 150/5300-13A<br>Chapter 3<br>Figure 3-23 | Correct non-standard condition | |
